# NAVAL POSTGRADUATE SCHOOL

## THESIS

USE OF IMPLANT TESTING TO EVALUATE  
THE SUSCEPTIBILITY OF HY-130 STEEL  
WELDMENTS TO HYDROGEN EMBRITTLEMENT

December 1981

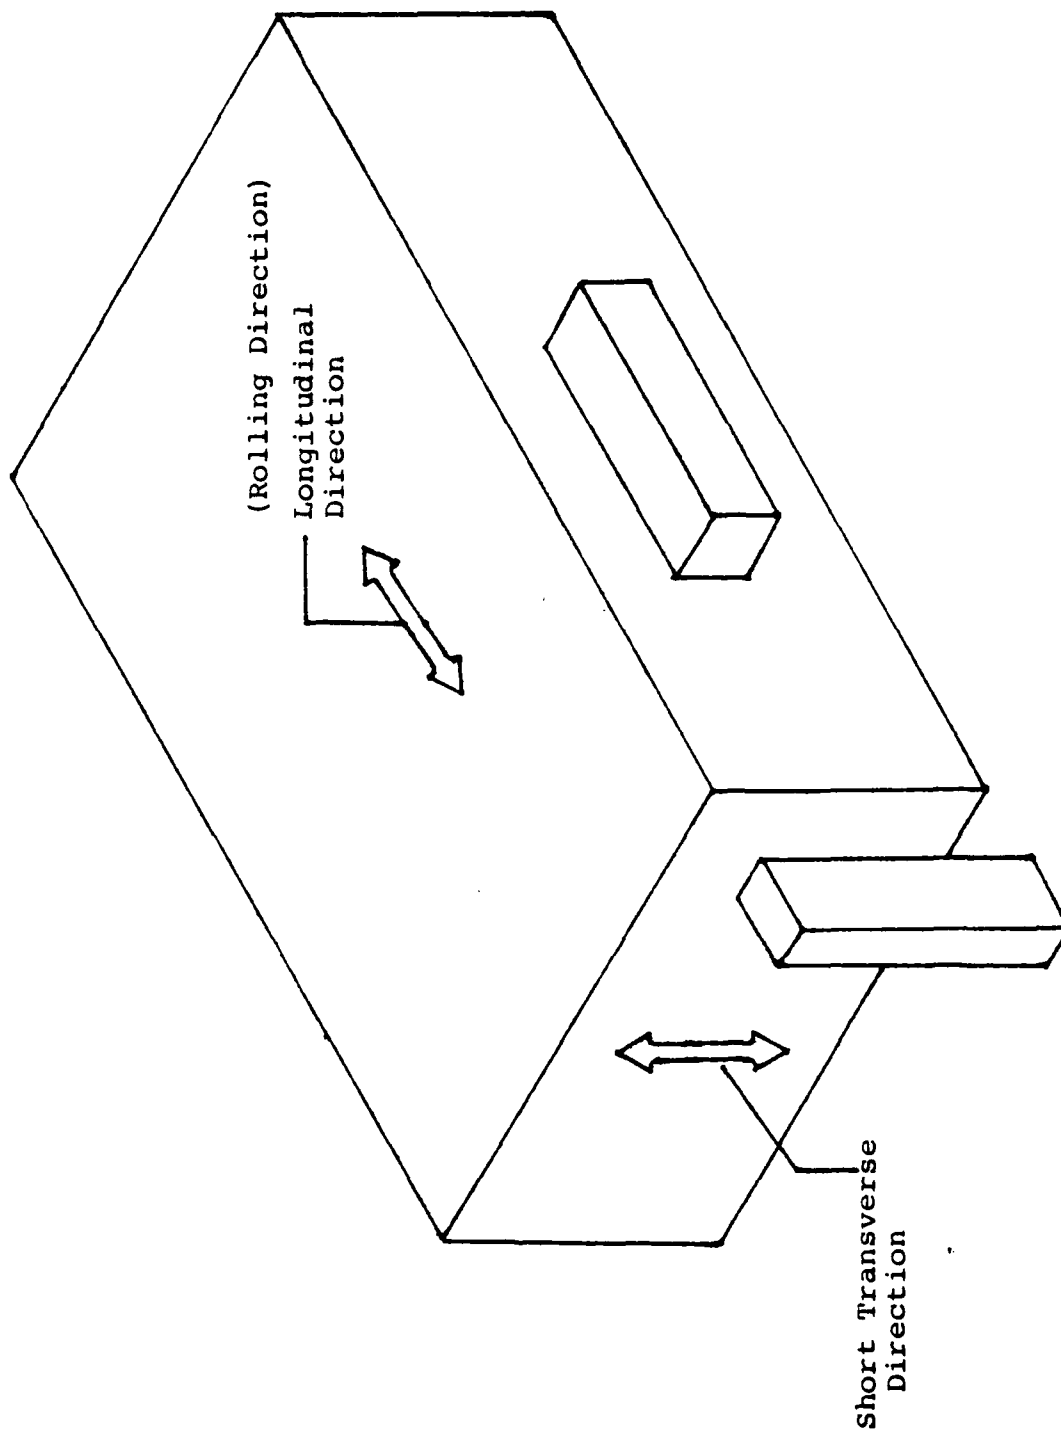
Figure 3. Orientation of Implant Test Specimens

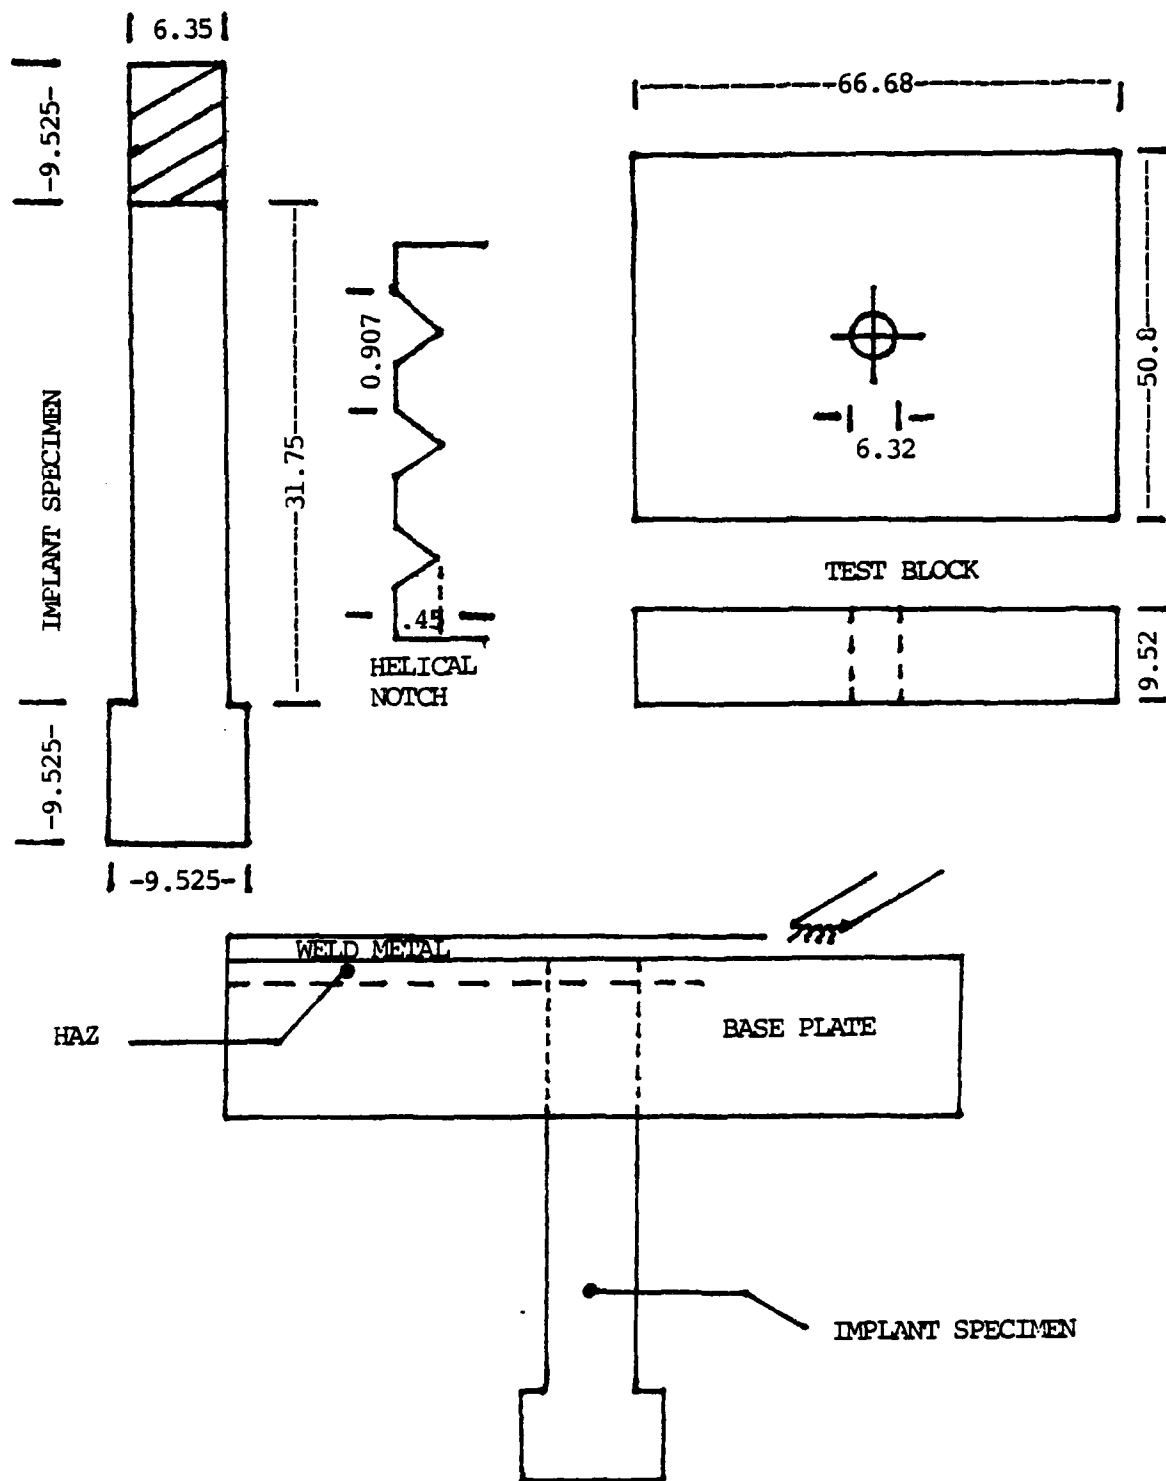
Figure 4. Details of Implant Test Assembly  
(dimensions in mm.)

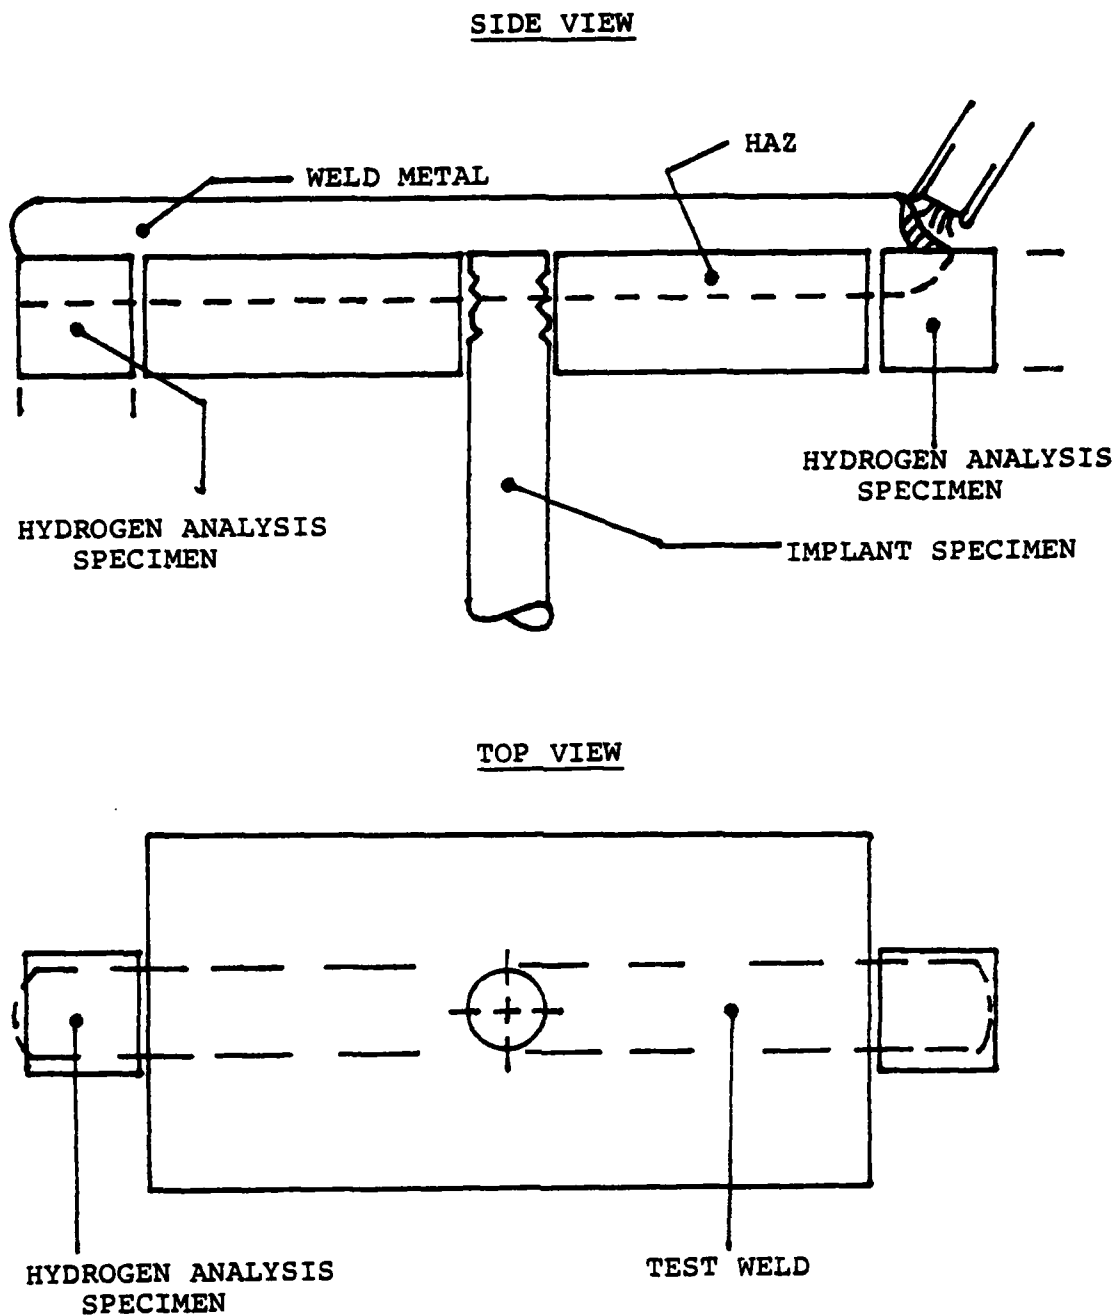
Figure 8. Orientation of Hydrogen Analysis Specimens During Implant Test Welding

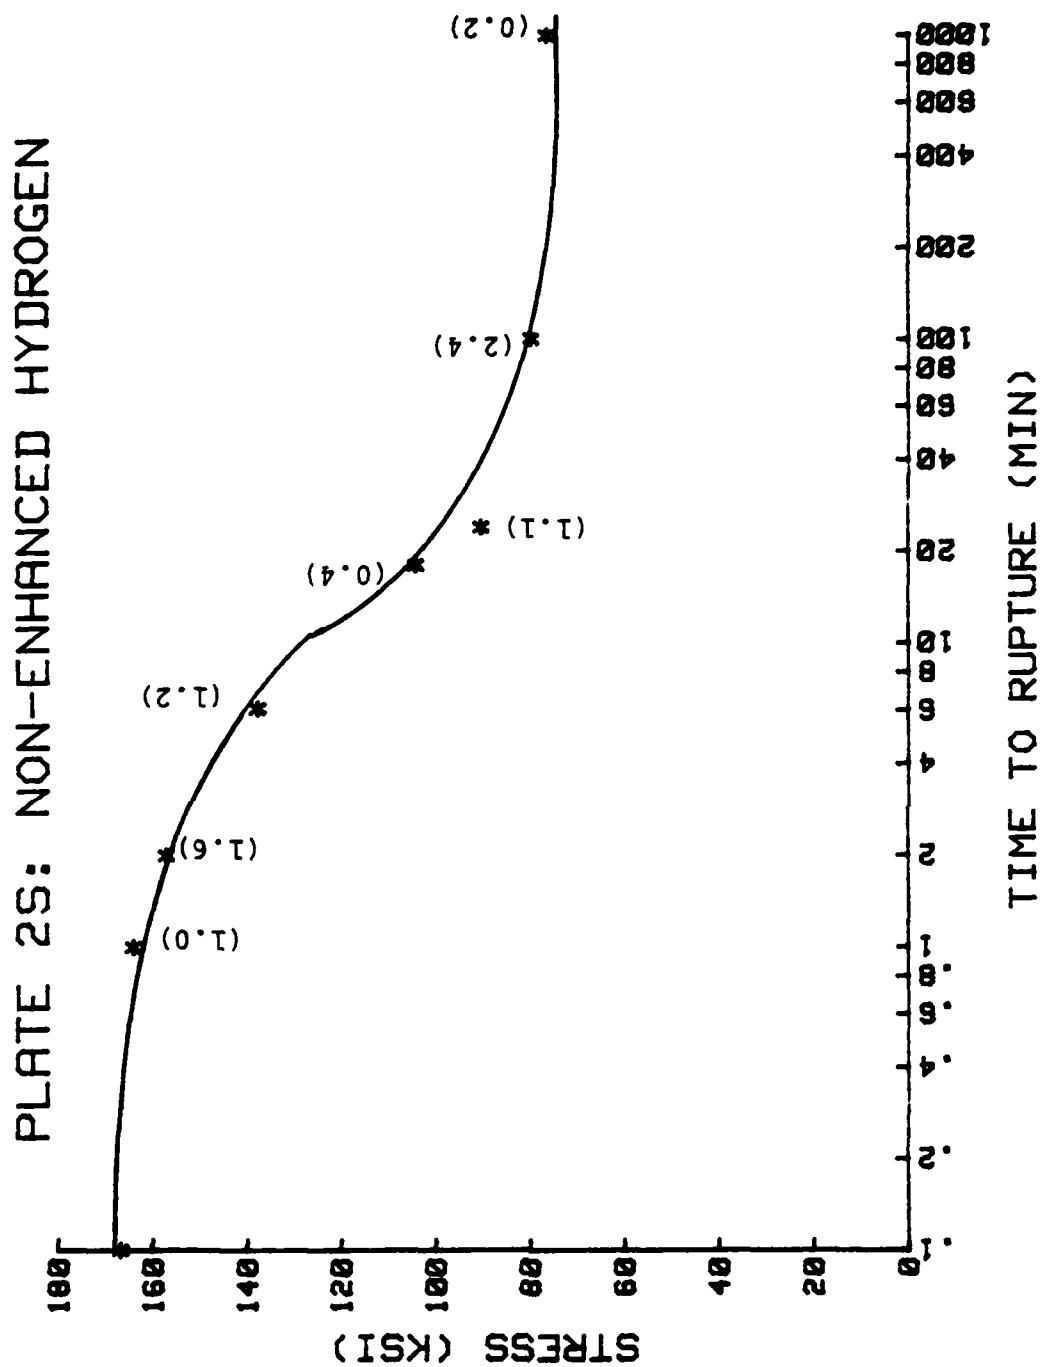
Figure 9. Stress vs. Time-to-Rupture for Plate 2 Short Transverse Direction Normal Welding Conditions

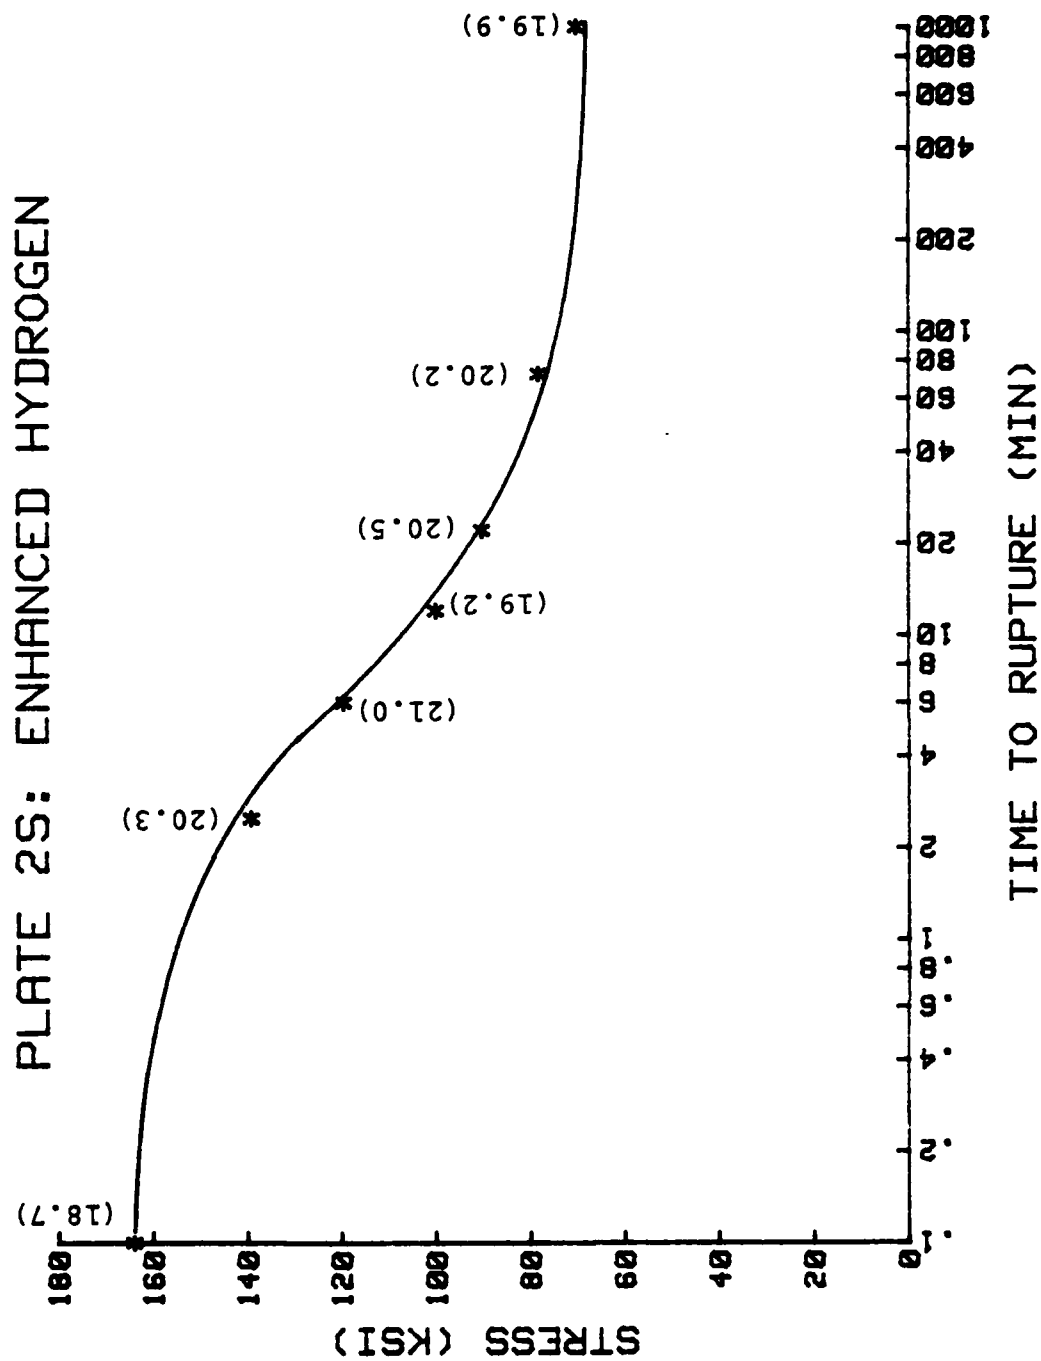
Figure 10. Stress vs. Time-to-Rupture for Plate 2 Short Transverse Direction Enhanced Hydrogen Welding Conditions

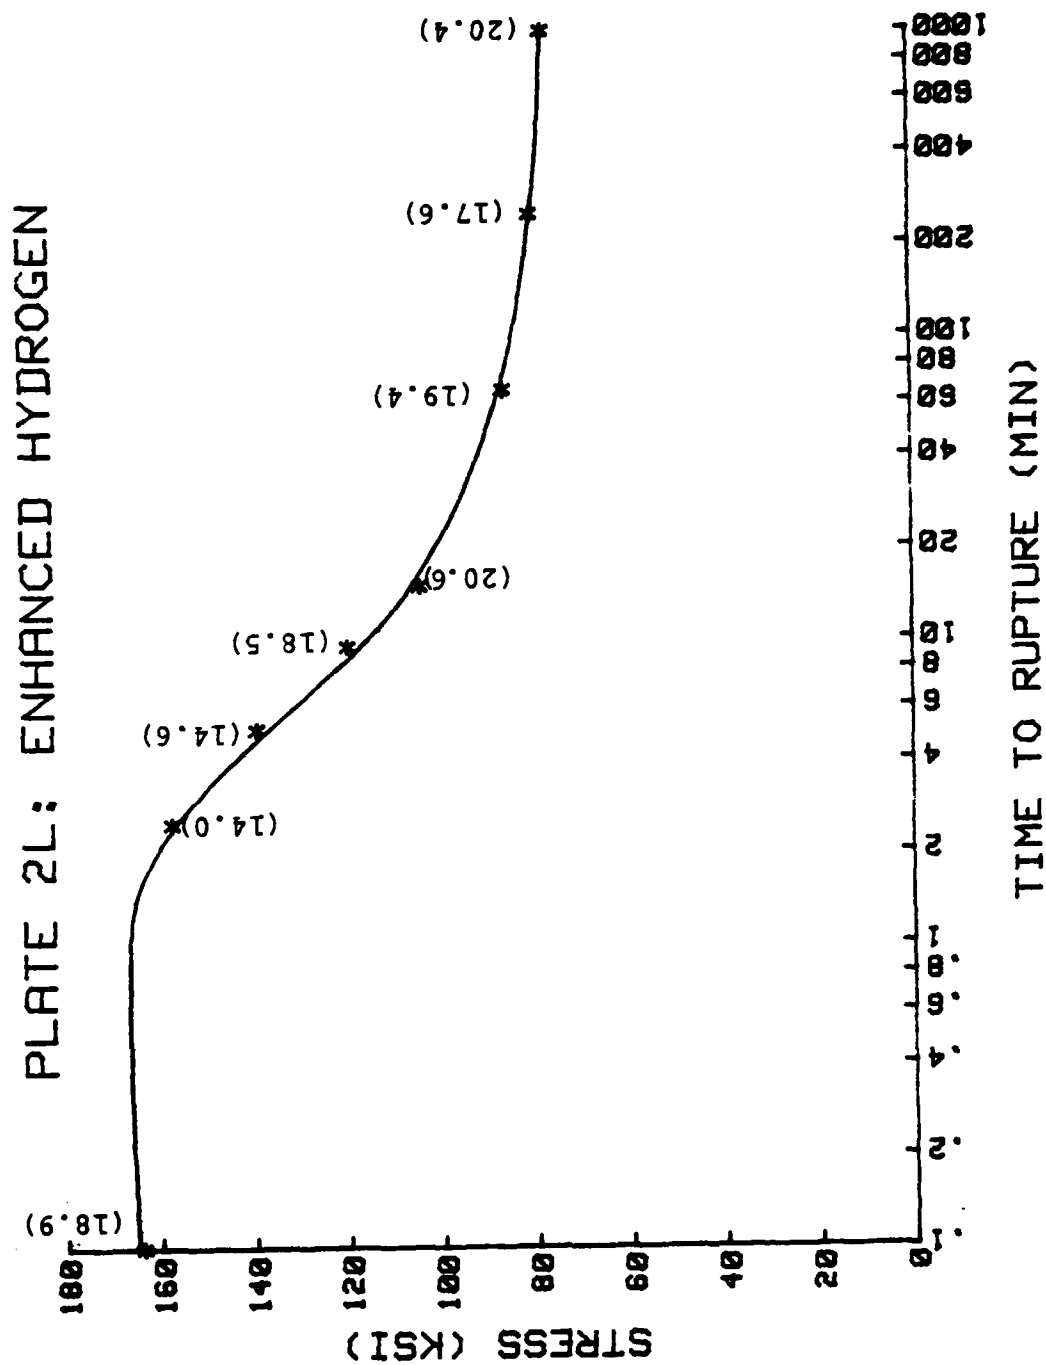
Figure 12. Stress vs. Time-to-Rupture for plate 2 Longitudinal Direction Enhanced Hydrogen Welding Conditions

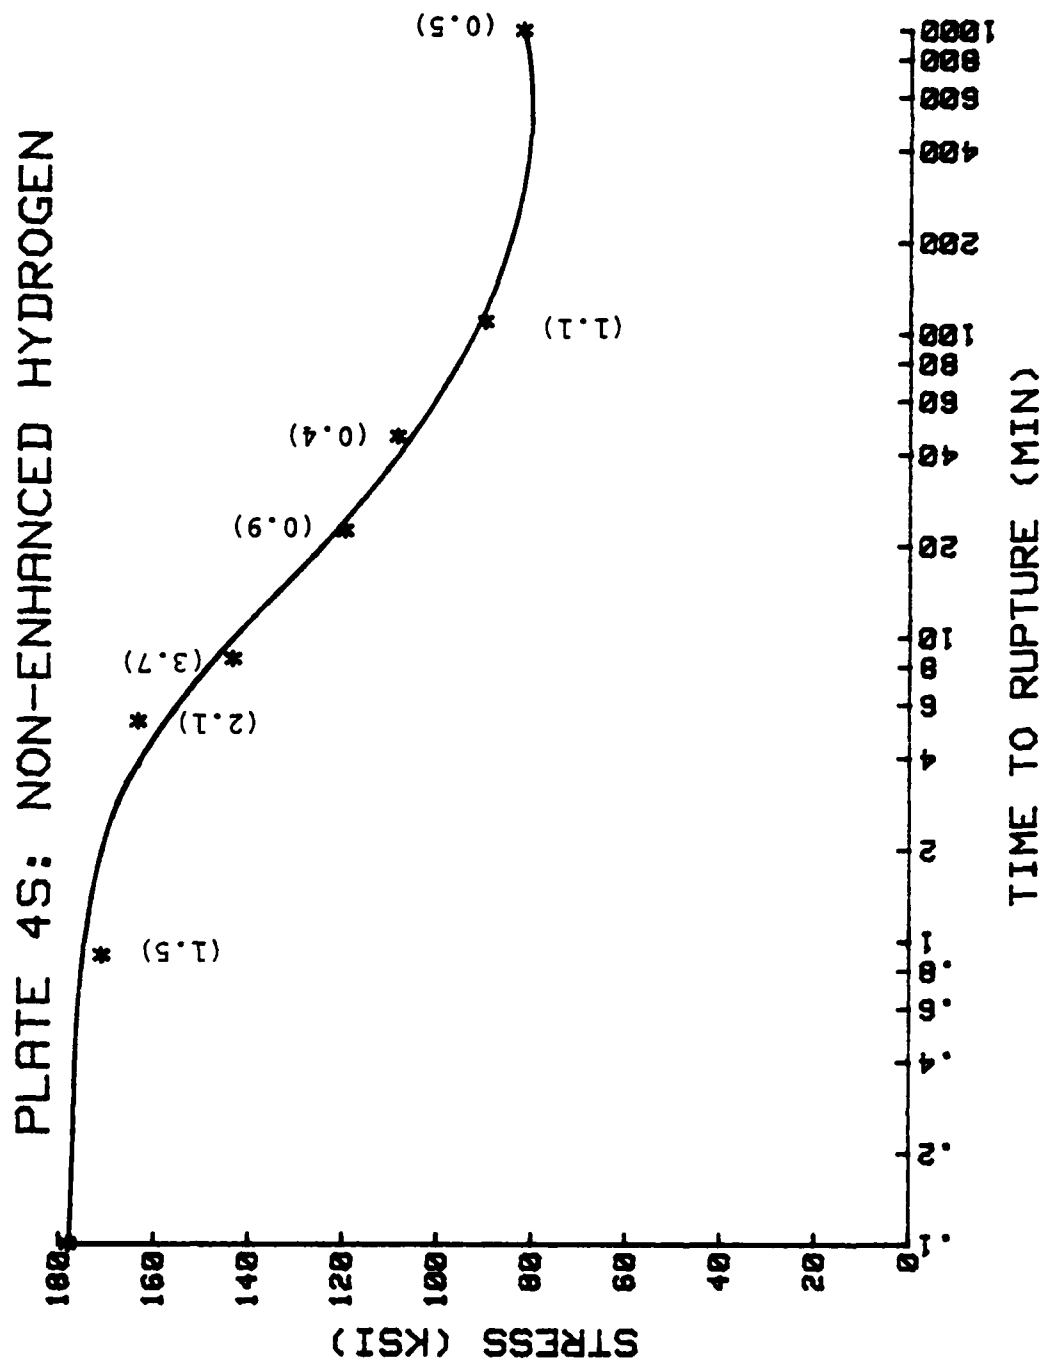
Figure 13. Stress vs. Time-to-Rupture for Plate 4 Short Transverse Direction Normal Welding Conditions

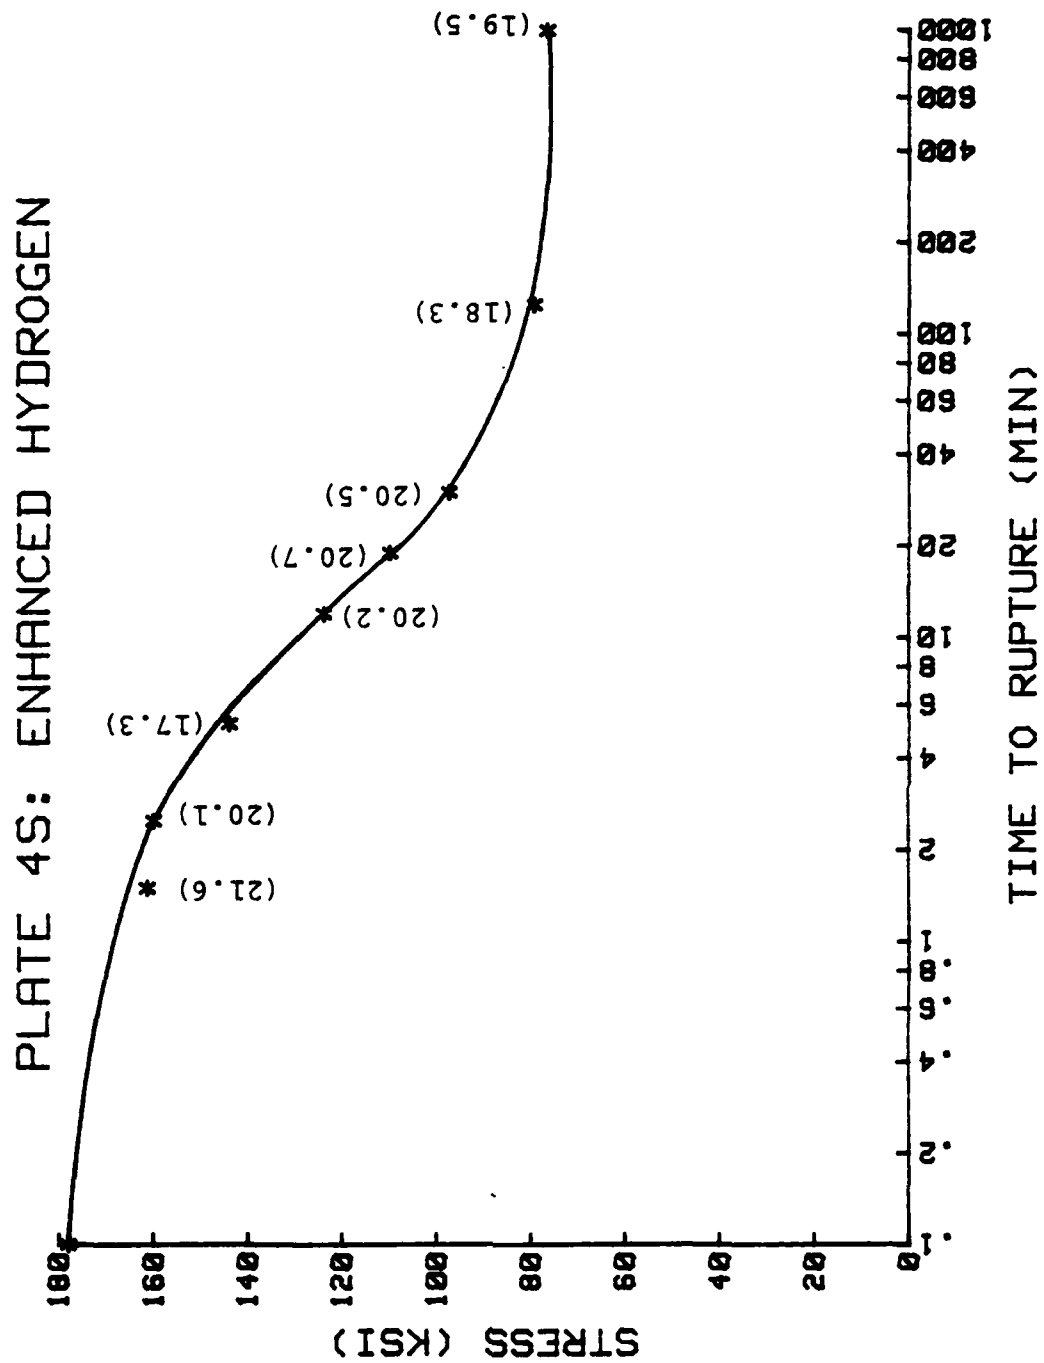
Figure 14. Stress vs. Time-to-Rupture for Plate 4 Short Transverse Direction Enhanced Hydrogen Welding Conditions

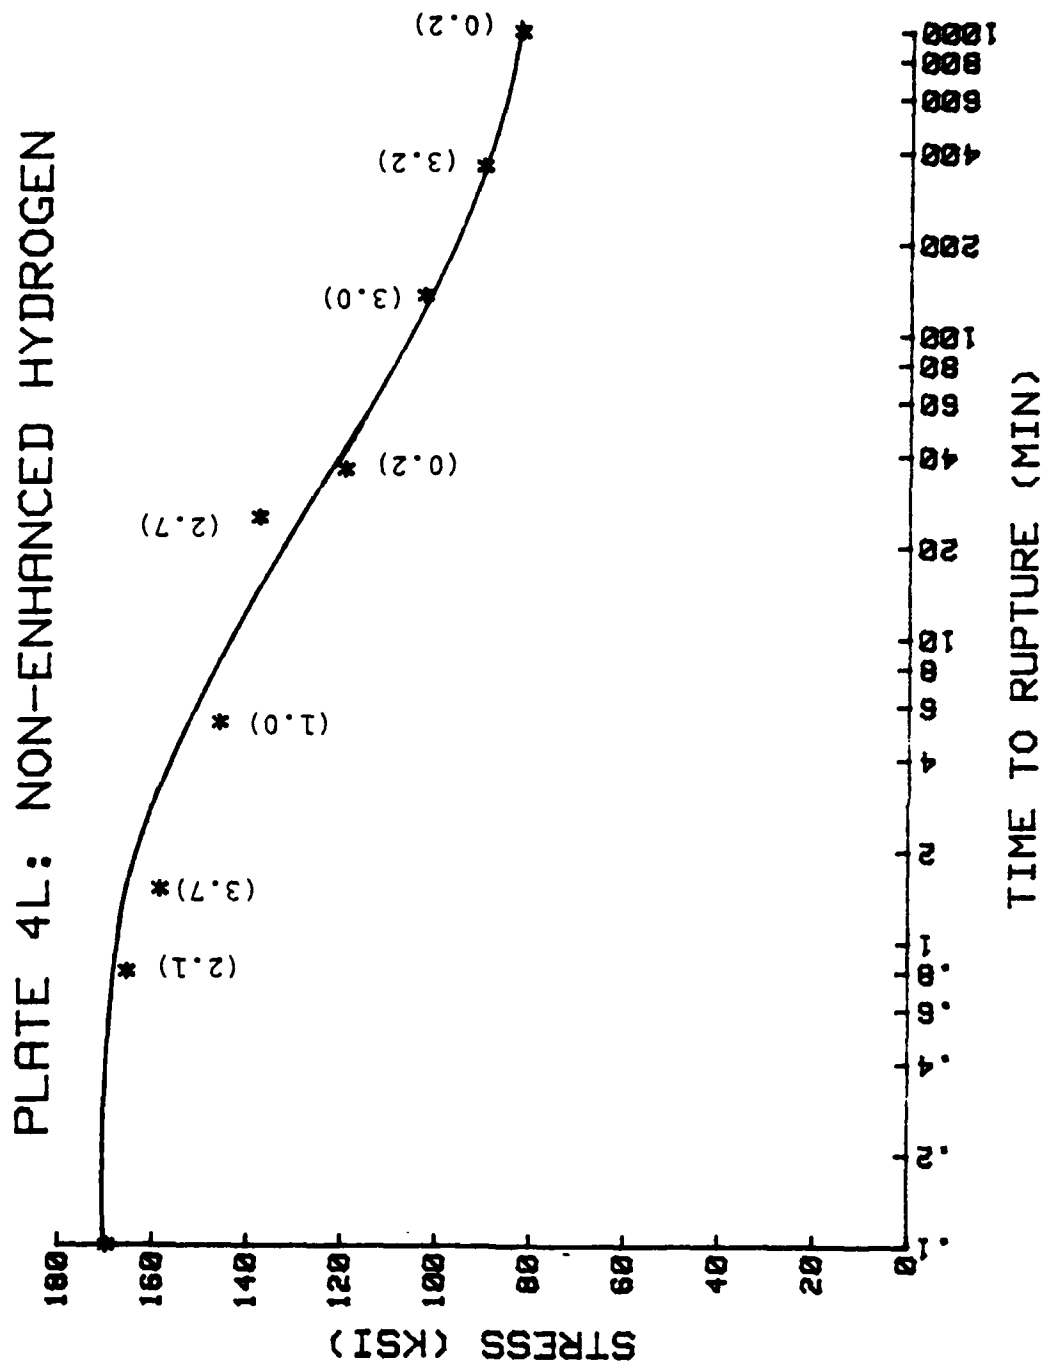
Figure 15. Stress vs. Time-to-Rupture for Plate 4 Longitudinal Direction, Normal Welding Conditions

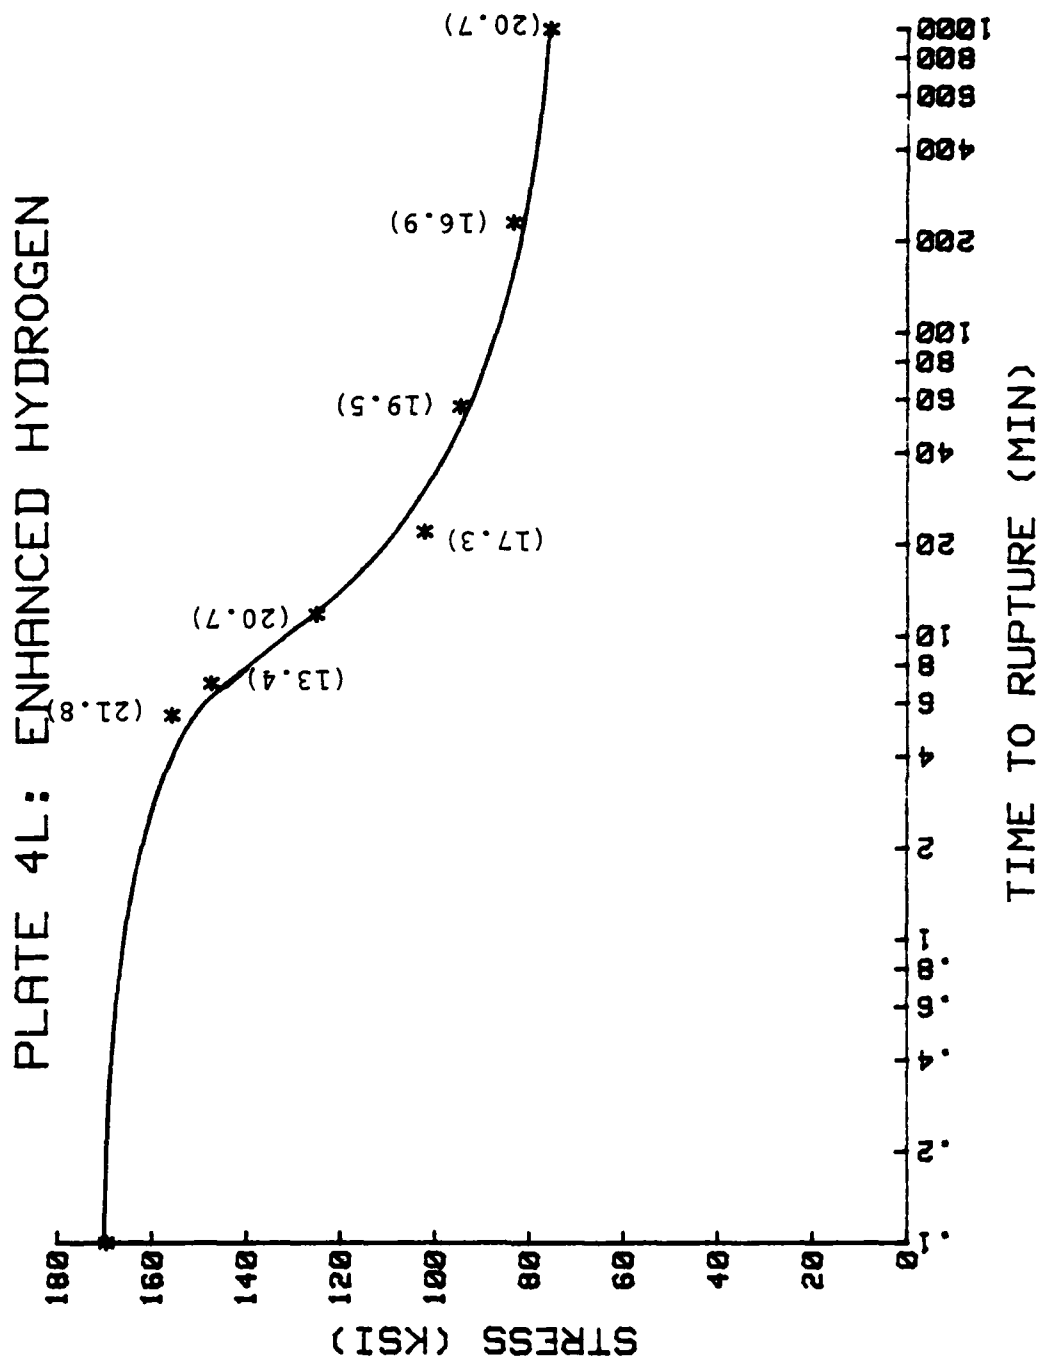
Figure 16. Stress vs. Time-to-Rupture for Plate 4 Longitudinal Direction Enhanced Hydrogen Welding Conditions

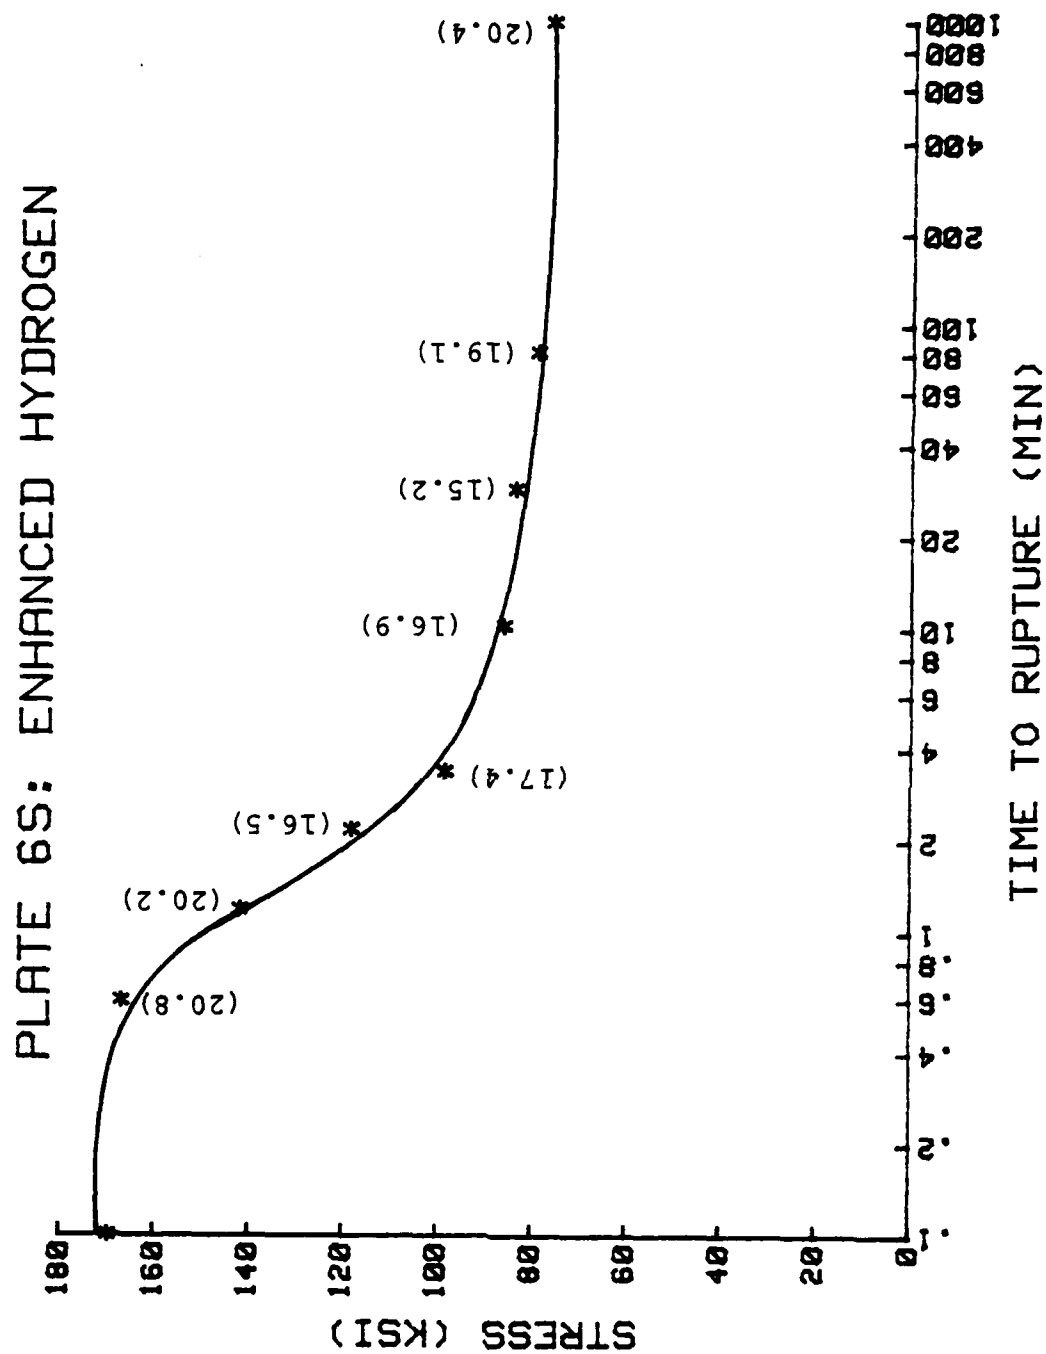
Figure 18. Stress vs. Time-to-Rupture for Plate 6 Short Transverse Direction, Enhanced Hydrogen Welding Conditions

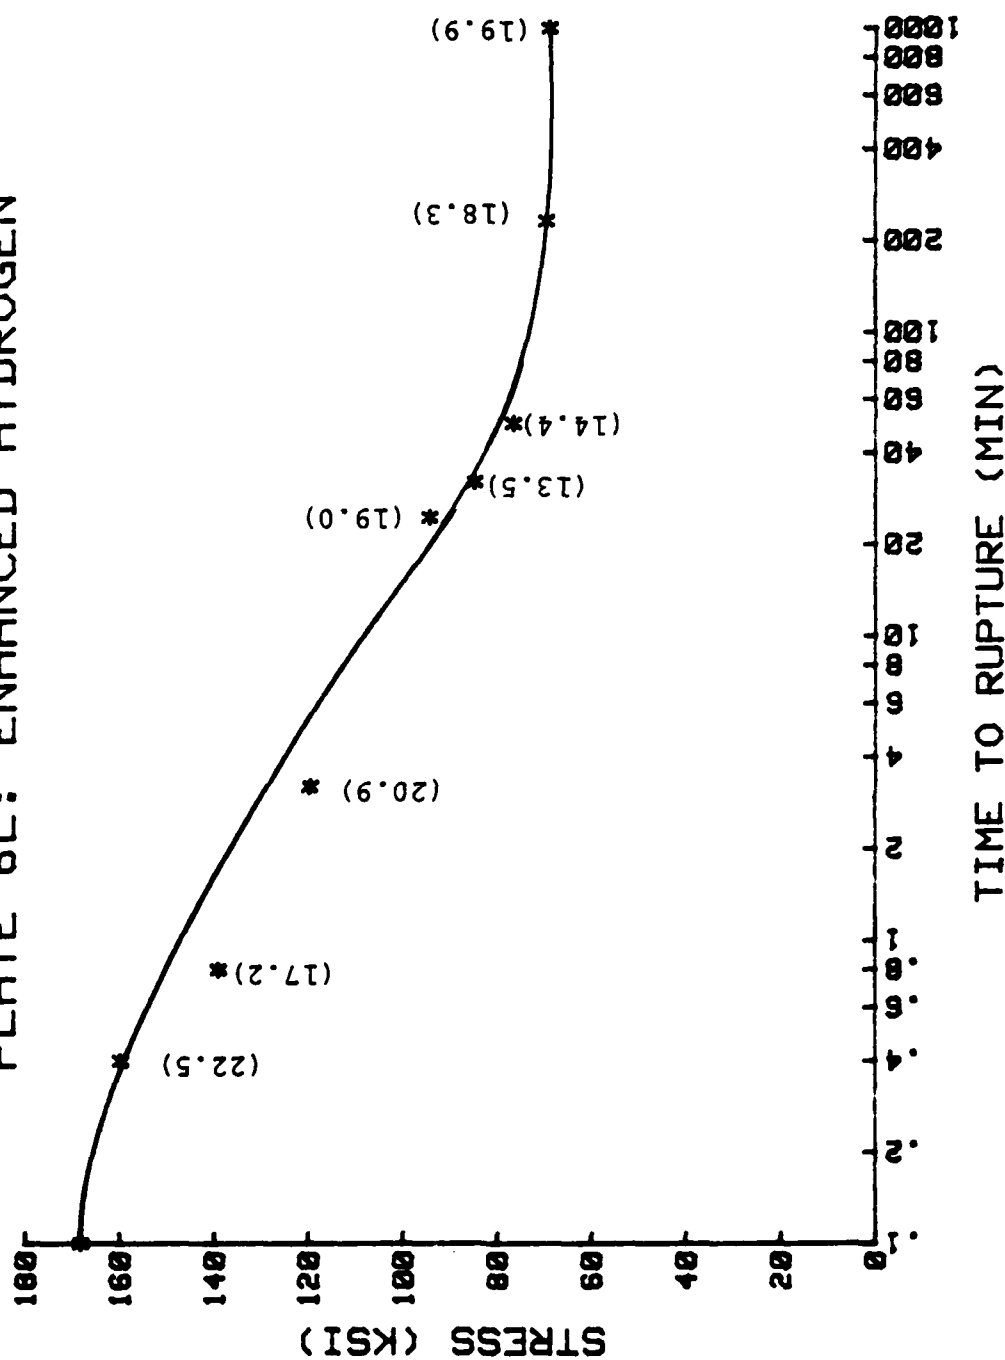
Figure 20. Stress vs. Time-to-Rupture for Plate 6 Longitudinal Direction, Enhanced Hydrogen Welding Conditions

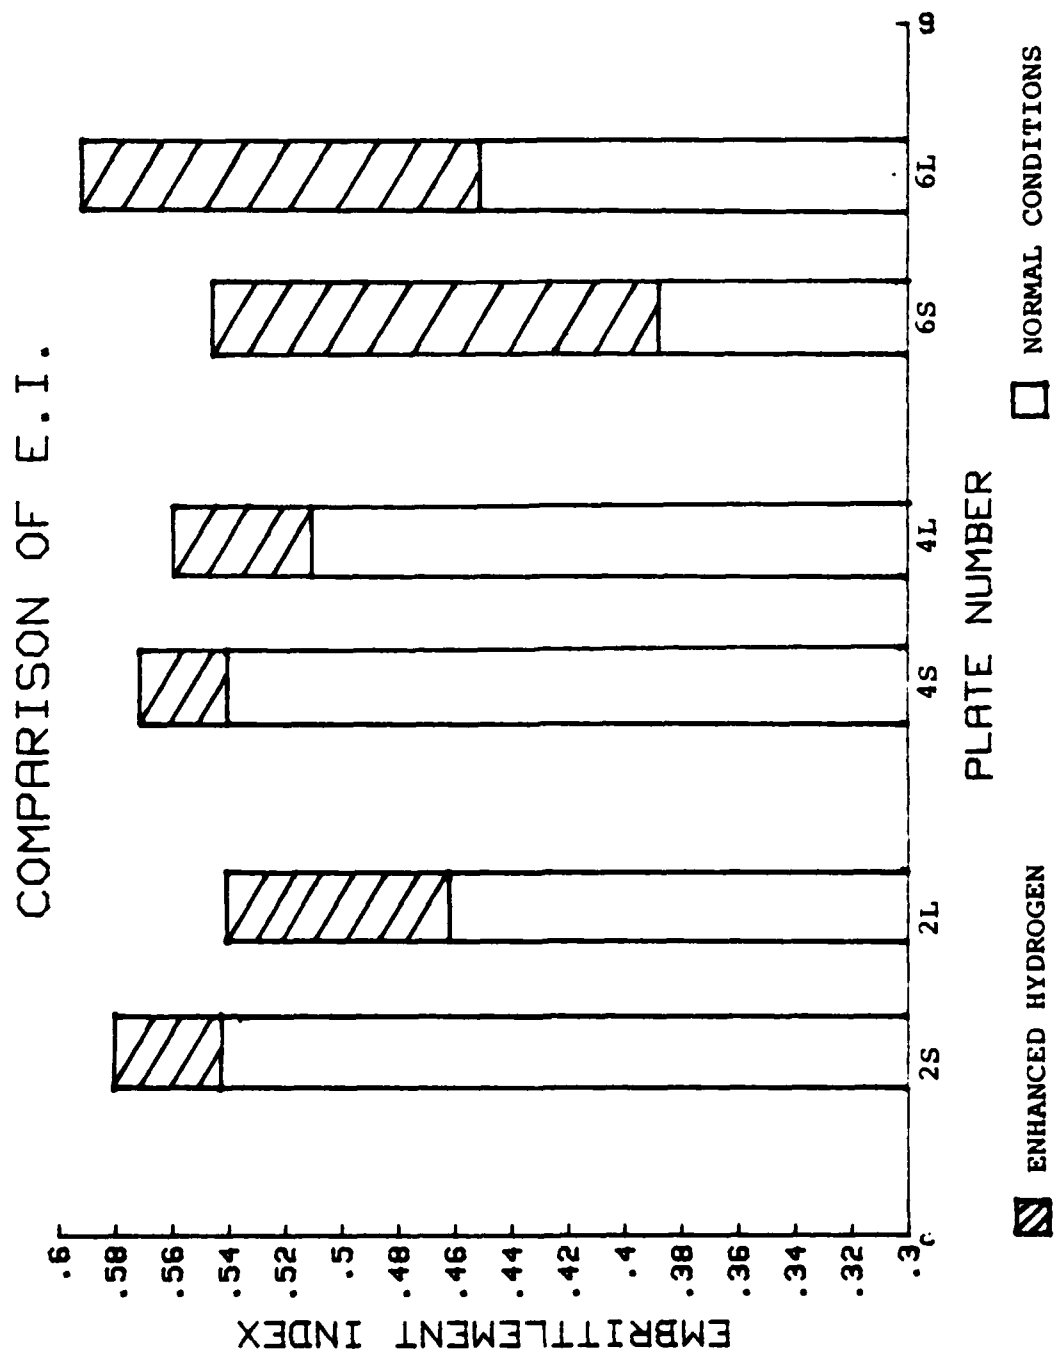
Figure 22. Comparison of the Embrittlement Index for Normal and Enhanced Hydrogen Welding Conditions

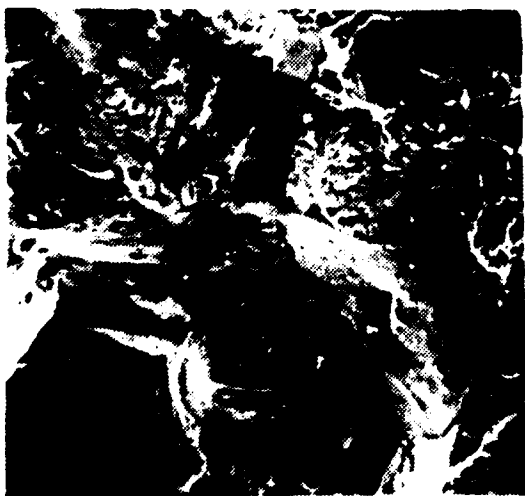
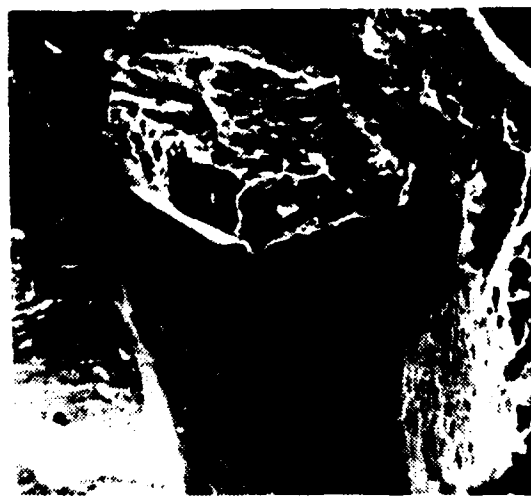
a) 50X, 2.4 ppm  $H_2$ , (70% Ductile)

b) 50X, 20.2 ppm  $H_2$ , (10% Ductile)

c) 500X - Dimpled Fracture

d) 500X - Dimpled Fracture

e) 500X - I.G. Fracture

f) 500X - I.G. Fracture

Figure 23. Plate 2, Short Transverse Direction, Normal (Left) and Enhanced Hydrogen (Right) Welding Conditions

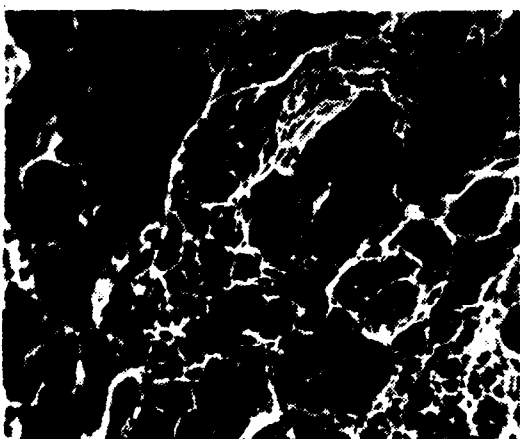
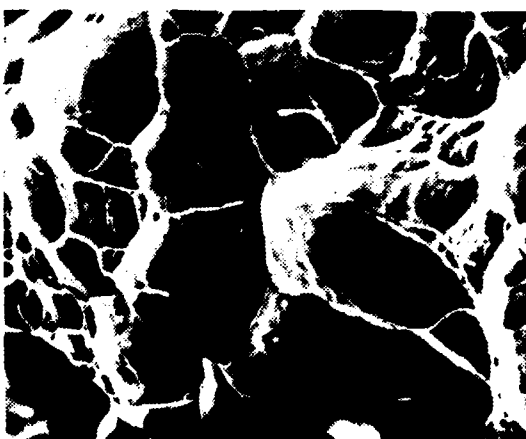
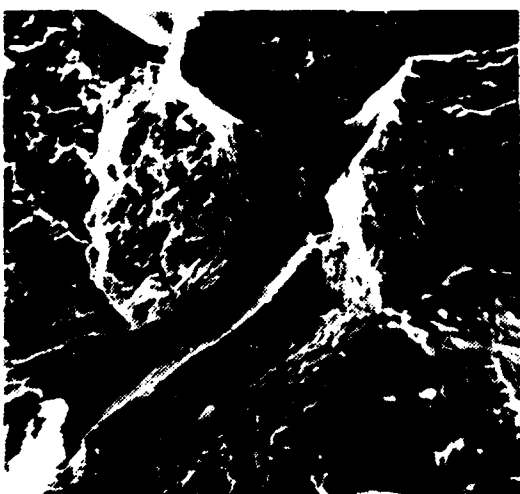
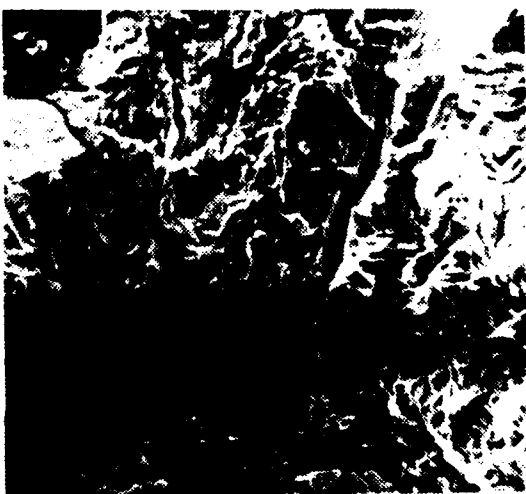
a) 50X, 1.1 ppm  $H_2$ , (70% Ductile)

b) 50X, 19.4 ppm  $H_2$ , (30% Ductile)

c) 500X - Dimpled Fracture

d) 500X - Dimpled Fracture

e) 500X - I.G. Fracture

f) 500X - I.G. Fracture

Figure 24. Plate 2, Longitudinal Direction, Normal (Left) and Enhanced Hydrogen (Right) Welding Conditions

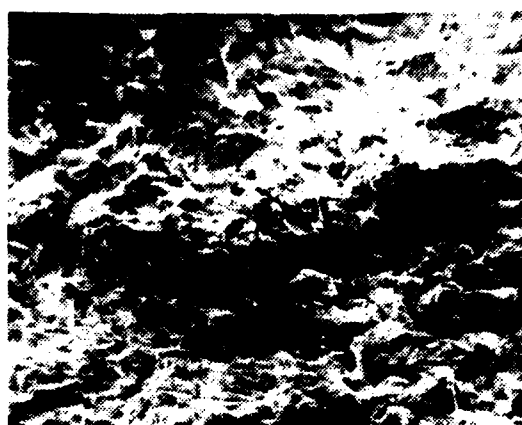
a) 50X, 1.1 ppm  $H_2$ , (80% Ductile)

b) 50X, 18.3 ppm  $H_2$  (25% Ductile)

c) 500X - Dimpled Fracture

d) 500X - Dimpled Fracture

e) 500X - I.G. Fracture

f) 500X - I.G. Fracture

Figure 25. Plate 4, Short Transverse Direction, Normal (Left) and Enhanced Hydrogen (Right) Welding Conditions

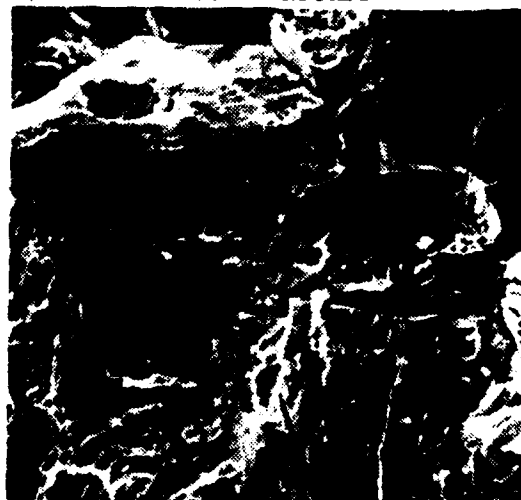
a) 50X, 4.2 ppm H<sub>2</sub> (85% Ductile)

b) 50X, 19.5 ppm H<sub>2</sub> (20% Ductile)

b) 500X - Dimpled Fracture

d) 500X - Dimpled Fracture

e) 500X - I.G. Fracture

f) 500X - I.G. Fracture

Figure 26. Plate 4 Longitudinal Direction Normal (Left) and Enhanced Hydrogen (Right) Welding Conditions

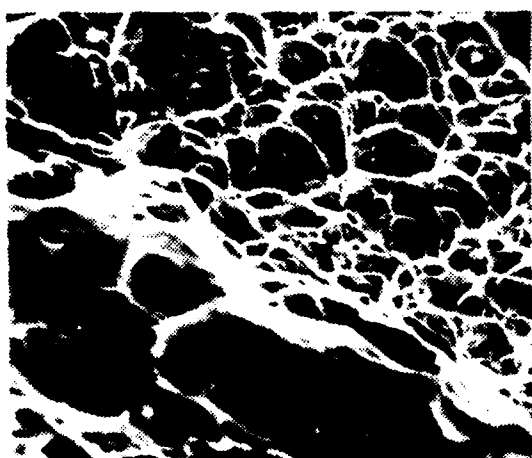
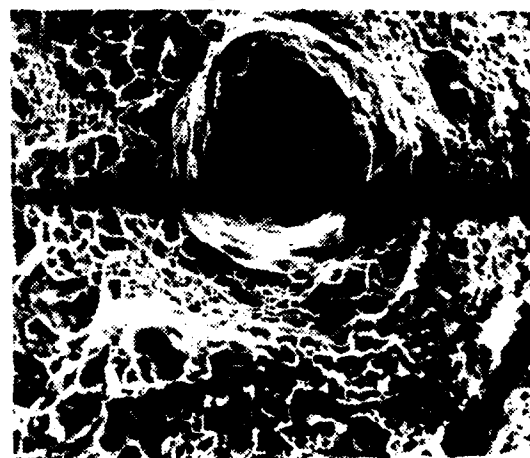
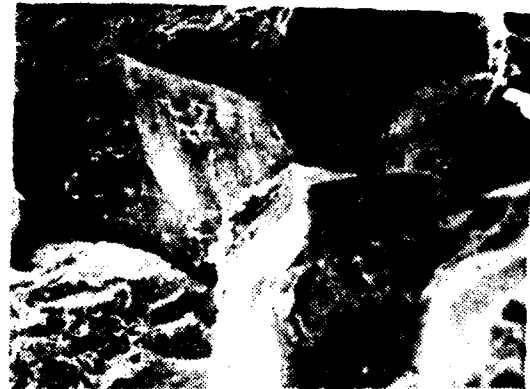
a) 50X, 0.7 ppm  $H_2$  (80% Ductile)

b) 50X, 19.1 ppm  $H_2$  (25% Ductile)

c) 500X - Dimpled Fracture

d) 500X - Dimpled Fracture

e) 500X - I.G. Fracture

f) 500X - I.G. Fracture

Figure 27. Plate 6, Short Transverse Direction, Normal (Left) and Enhanced Hydrogen (Right) Welding Conditions
